# Forensic Investigation of the Deepwater Horizon Blowout Preventer

Shane R. Finneran, Barbara N. Padgett, Brandon C. Rollins, and Neil G. Thompson

Det Norske Veritas (U.S.A.), Inc.

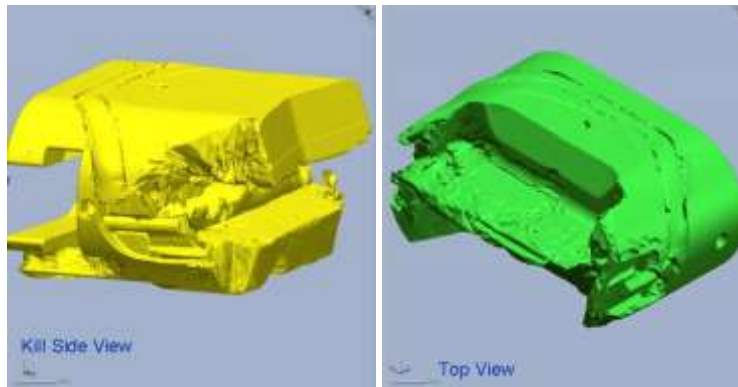
Three-dimensional laser scanning provided a means of characterizing surfaces in a quantitative manner and permitted ease of orientation of complex surfaces, as shown in Figure 2. Figure 3 and Figure 4 show that significant erosion occurred on the upper and lower BSR blocks. In order to quantify the erosion damage to the BSR blocks, the laser scan models were compared with design CAD models depicting the nominal geometry for the upper and lower BSR blocks. A contour surface plot of the deviation between the recovered blocks and the CAD model was developed. Figure 3 and Figure 4 show an overlay comparison for the BSR blocks with the laser scan model of the recovered BSR shown as a deviation plot, while the nominal CAD model is overlaid as translucent and outlined. It should be noted there was more damage to the kill side of both the upper and lower BSR than the choke side. The elastomer on the side packers was completely missing and much of the metallic side packer components were eroded away.

Figure 2. 3D laser scan of Upper (Yellow) and Lower (Green) BSR blocks

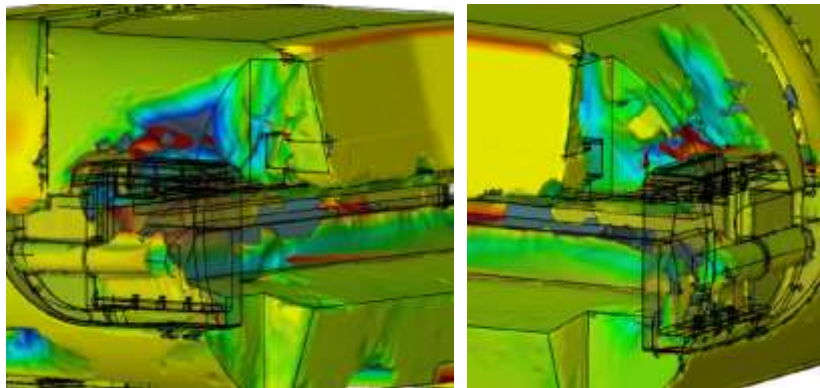
Figure 3. Deviation plots of Upper BSR. (Kill side view on left)

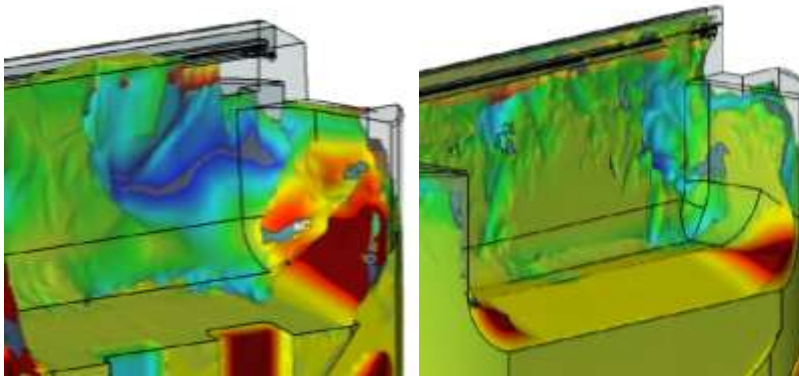
Figure 4. Deviation plots of Lower BSR. (Kill side view on left)

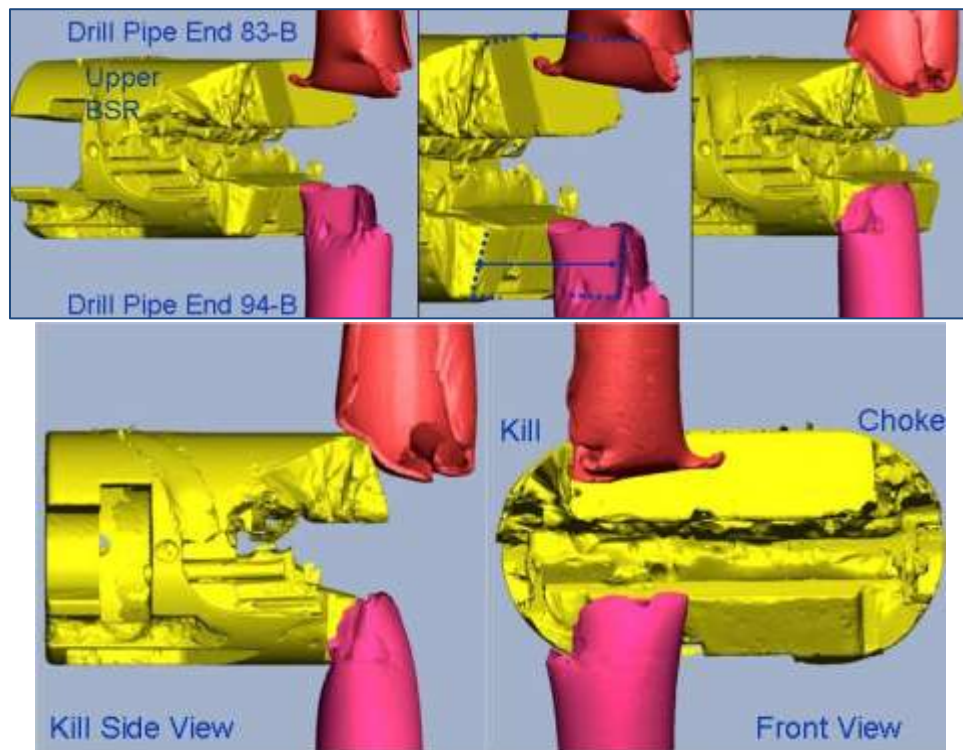
Two ends of the recovered drill pipe segments, identified as Pipe Segments 83-B and 94-B in Figure 5 below, were postulated to be partial BSR cuts. This conclusion was based on recovery locations, and visual examination. The physical evidence indicated the drill pipe was out of alignment with design cutting planes of the BSRs. Figure 5 presents the proposed alignment of 3D laser scans of the top and bottom drill pipe segments at the BSR. The features aligned were prominent flat indications and missing corners on the segments cut by the BSR. The aligned features suggest that the drill string was not centered in the well bore at the time of cut. As the BSRs closed, the off centered drill string was positioned such that the corner of the BSR blade prevented the rams from fully shearing the pipe and sealing the well. Theoretically, minor misalignment of the drill pipe should be corrected by the design of the BSR blades, VBRs, and annulars. The digital reconstruction suggested the drill pipe misalignment was not corrected, and it was then necessary to determine why the BOP did not hold the drill pipe centered as designed.

**Figure 5. Laser scans of 94-B and 83-B matched against the upper BSR block**

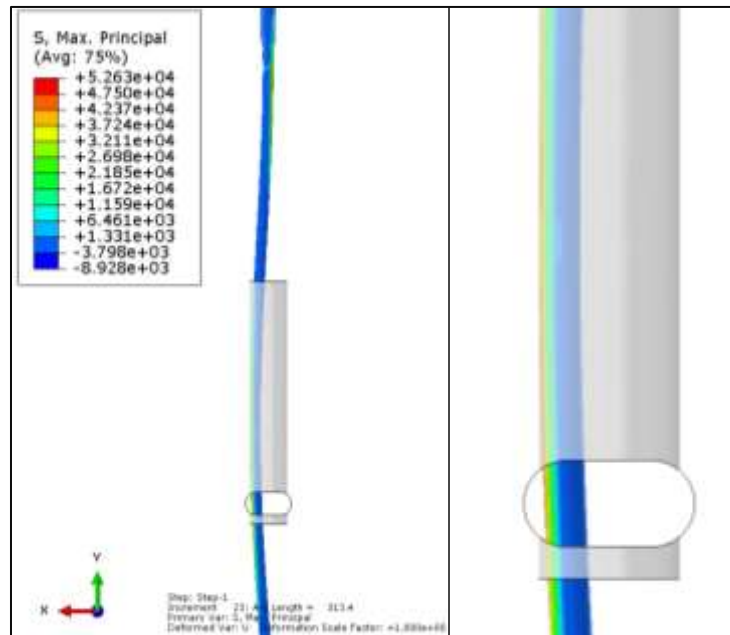
The axial load components were added in a static Rik's type analysis to approximate the post-buckling deformation of the drill pipe. Rik's method is capable of varying the applied load components as the pipe deforms allowing the analysis to account for the non-linear effects expected as buckling progresses. The models were solved using Abaqus/Standard. The initial buckling analysis predicted a single waveform buckling mode, at a critical axial load of 113,500 lbs. The predicted deformation and resulting stresses are shown in Figure 7. The predicted deformation showed the peak curvature of the buckle would contact the wellbore slightly above the BSR cavity, holding the pipe against the side of the wellbore.

**Figure 7. Predicted deformation and resulting stresses due to buckling**

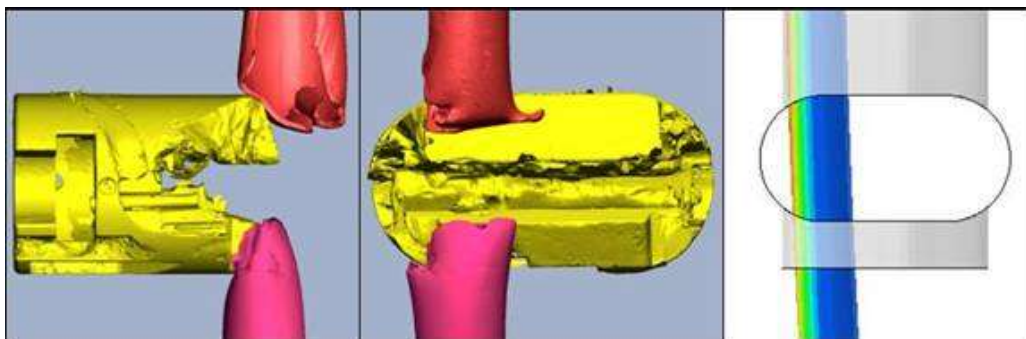
Physical indications on the ends of Pipe Segments 94-B and 83-B were matched to the outer corners of the upper BSR block as discussed in Section 2.3 above. These indications were aligned with the upper BSR block features to determine the position of the drill pipe within the wellbore. Figure 8 shows a comparison of the aligned pipe segments with the predicted drill pipe position, relative to the BSR cavity, from the buckling analysis.

**Figure 8. Alignment of pipe segments with BSR and buckled pipe displacement comparison**

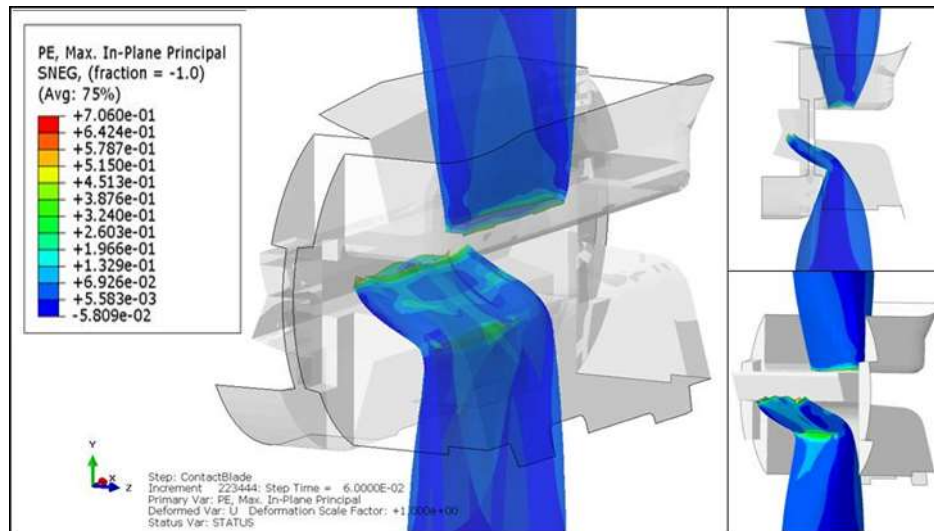
The BSR is designed to fold the end of the lower pipe segment over to prevent damage to the lateral sealing element behind the upper blade as it passes across. Testing has shown that the lower pipe can fracture at the fold point. The centered pipe shear analysis calculated a strain concentration of 32% along the inner bend as seen in Figure 12, matching with the fracture area observed on physical tests.

**Figure 12. Abaqus FEA model results showing the final deformation of drill pipe at BSR when properly centered.**

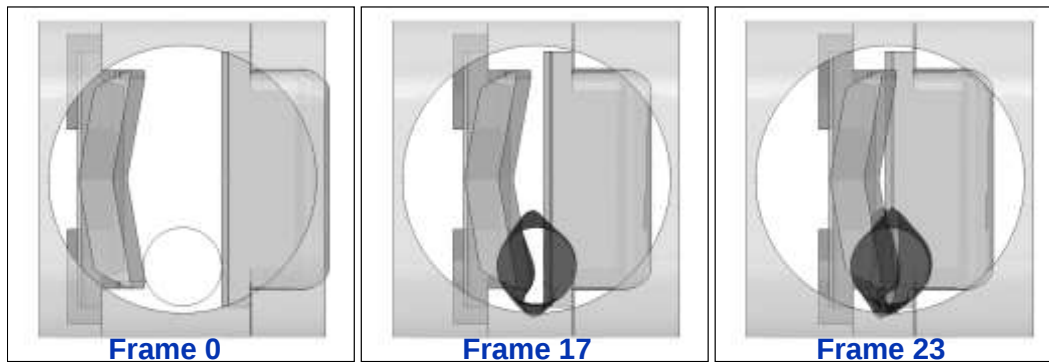
The off-center shearing analysis demonstrated that with the pipe at the edge of the wellbore, as observed on the recovered drill pipe and predicted by the elastic buckling FEA, the pipe would be deformed outside of the shearing blade. This would have prevented the BSRs from fully shearing and cutting the drill pipe, preventing full closure of the BSRs and sealing of the well. Rather than closing with the sealing surfaces in contact, the drill pipe was deformed and collapsed between the outer faces of the BSRs, outside of the cutting plane, as shown in Figure 13 and Figure 14. The final predicted FEA model simulation was compared with the recovered drill pipe as shown in Figure 15. As shown in the figure, the model of the drill pipe matched well with the indications identified on the recovered forensic evidence.

**Figure 13. Top View Showing Deformation of Drill Pipe Outside of Shearing Blade Surfaces**

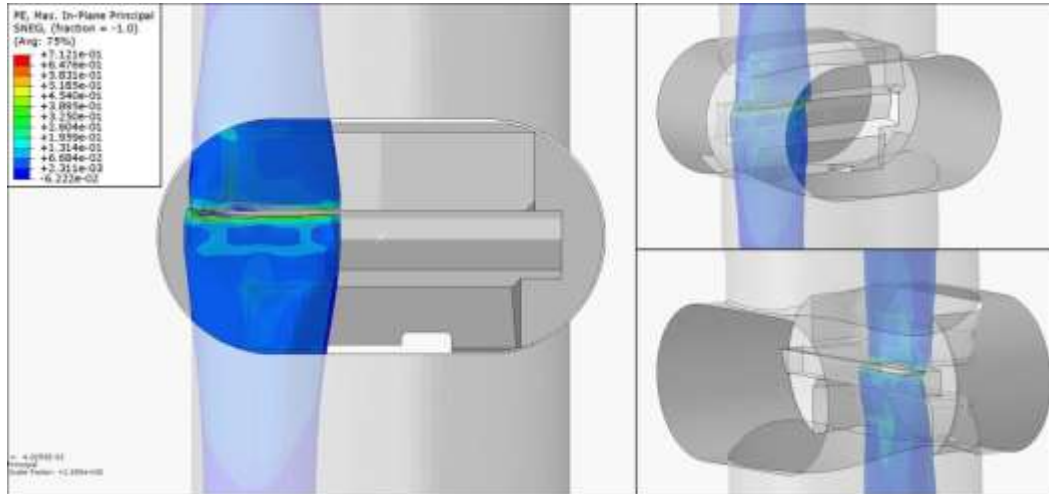
**Figure 14. Abaqus FEA model results showing the final deformation of off-center drill pipe at BSR.**

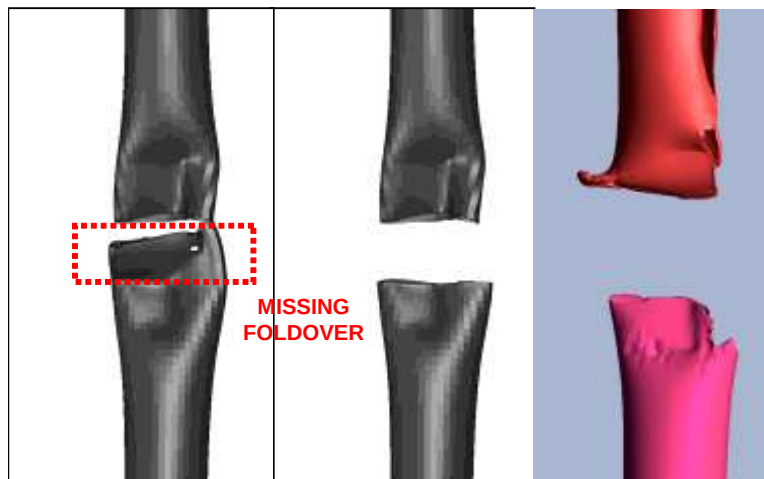
**Figure 15. Final model deformation compared with recovered drill pipe laser scans**

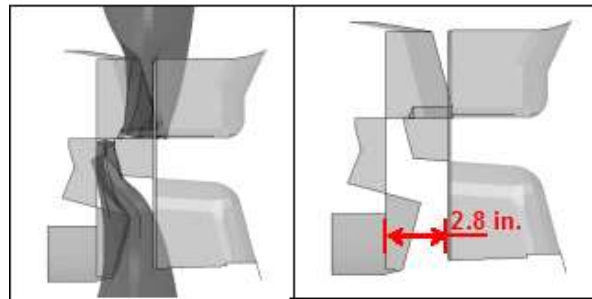
The models of the upper and lower BSR were aligned at the predicted 2.8 inch spacing, and the lower BSR fit against the lower drill pipe segment. The predicted configuration at the expected stall point is shown below in Figure 17 showing the significant erosion to the BSR block and packer seals. This prevented the BSR from sealing and allowed for continued flow path through and around the BSR. Erosion to the kill side of the BSRs aligned with the heavy erosion damage on the interior of the wellbore (shown in blue in Figure 17). The extensive erosion on these components created an alternate flow path that could not be sealed even if the BSRs were to fully close at a later point.

Figure 16. Spacing of upper and lower BSR blocks in partially closed position

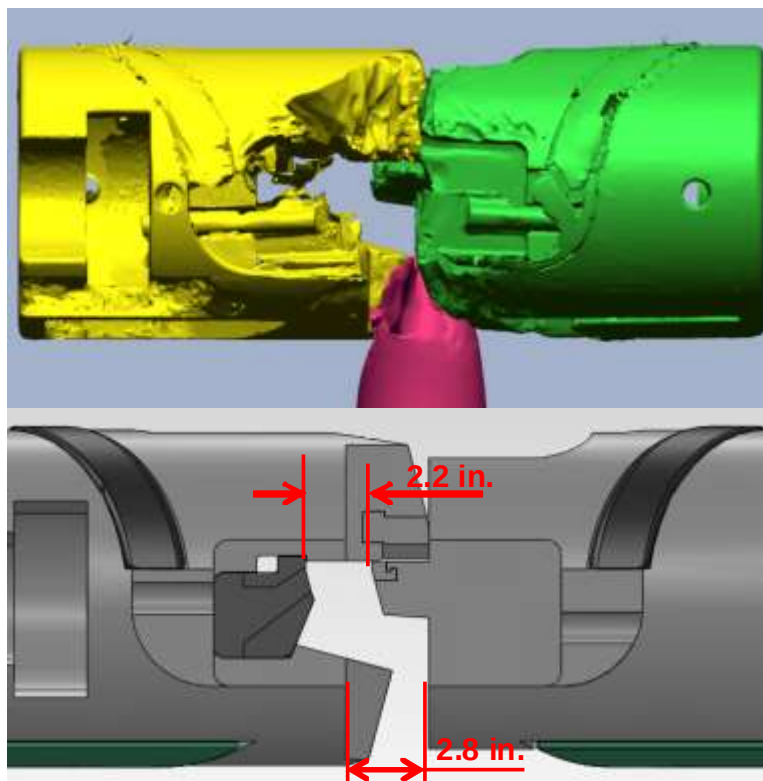
Figure 17. Alignment of scan models and design CAD models showing approximate standoff between BSR faces
