# Finite Element Analysis of Rubber Treads on Tracks to Simulate Wear Development

Sergio G. Arias, Ph.D.

Advanced Technology Group, Camoplast Solideal Inc.

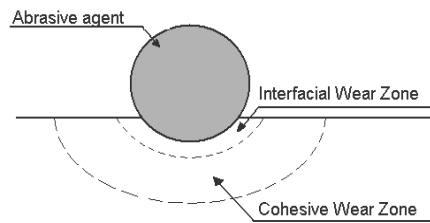
**Figure 1 - Schematic of wear zones in a typical rubber-like material**

For the research conducted in this paper, the type of wear that is of most interest to us is that of rubber-like materials. According to some researchers, rubber wears by two main mechanism; tearing (fracture) and fatigue. In both mechanisms, they arise from high local friction effects at or near the contact surface. These areas can be characterized into two areas of interest, as seen in Figure 1: the Interfacial wear zone and the cohesive wear zone. Depending upon some key material properties, such as the tensile strength of the rubber, one would obtain different mechanism and rates of wear developing at these areas.

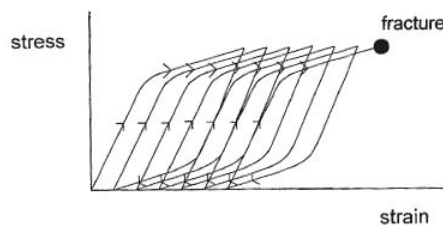
In a repeated-cycle deformation, the wear mechanism requires repeated cycles of deformation to cause failure. This wear mechanism is too found at the cohesive wear zone. In these types of processes, the plastic strain is accumulated, nucleating more and more cracks and propagating them throughout the cycles, to the point of fracture. This is symptomatic of cyclic fatigue wear. The following figure shows a schematic of this wear development.

**Figure 2 - Illustration of repeated stress cycling leading to fracture**

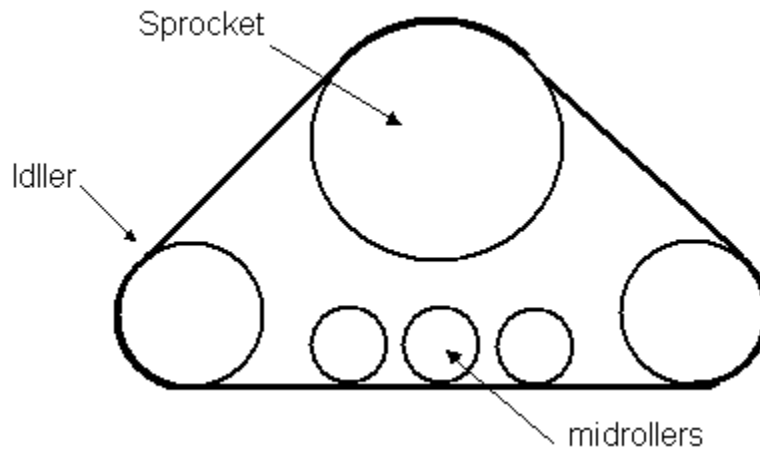
For the purpose of this research, the case of the abnormal wear development in the rubber tracks of a caterpillar-type vehicle was selected. Figure 3 shows an schematic of the assembly of a typical positive-drive rubber track agriculture vehicle.

**Figure 3 – Schematic of a typical positive-drive rubber track system**

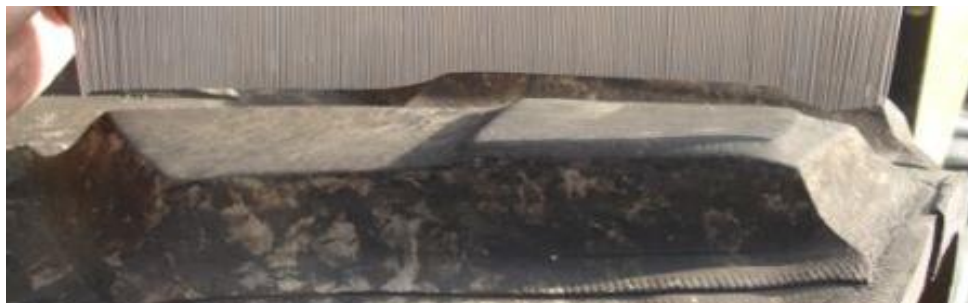
Field studies showed that the tracks produced localized areas of wear in the treads, even after only several hours of use. These areas of abnormal wear, which are clearly defined as seen in Figure 4, are located in the inside part of the contact area of treads with the ground surface (away from the region of pressure induced by the midrollers). The reason why this occurs is not clear, since logic dictates the treads should either wear nearly evenly or where most contact pressure occurs. The following figure shows an example of a typical wear tread on a harvest combined vehicle track.

**Figure 4 - Localized tread wear**

Upon visual examination on the rubber tracks, it was clear that the areas of high wear were perfectly defined to be in the sections away from the roller path. In other words, the high wear was located at the inside areas of the treads. The areas where the midrollers passed by, as the vehicle rolls, showed minimal wear, and more consistent to what is expected to deteriorate the treads after hours of use.

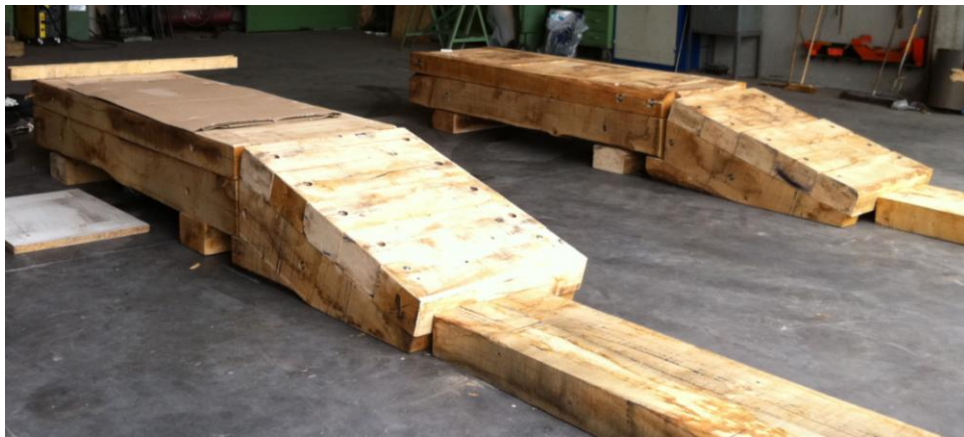
To study more closely this phenomenon, a camera was rigged in cage with a glassy surface such that it would record the deformations of the treads as the undercarriage system of the vehicle rolled over it. The following figure shows the setup created to conduct these experiments.

**Figure 5 - Field Testing Setup to measure tread deformation**

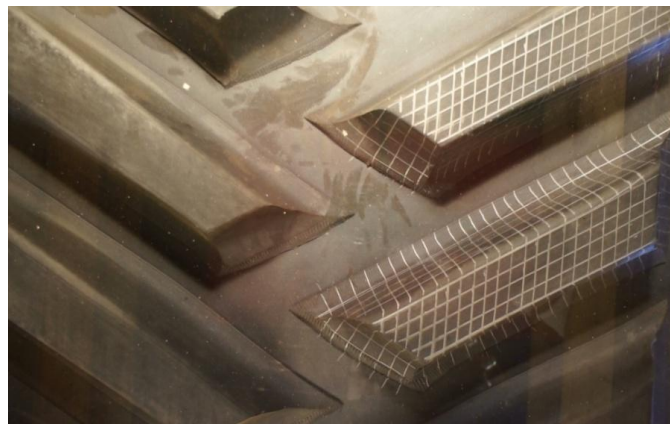
To produce a clearer visual measure of the tread behavior as the midroller passed them by, a discretized mesh was drawn over several treads (as seen in Figure 6). This field testing setup provided us with sufficient visualization of the mechanisms of tread deformation.

**Figure 6 - Field testing visual observation set up**

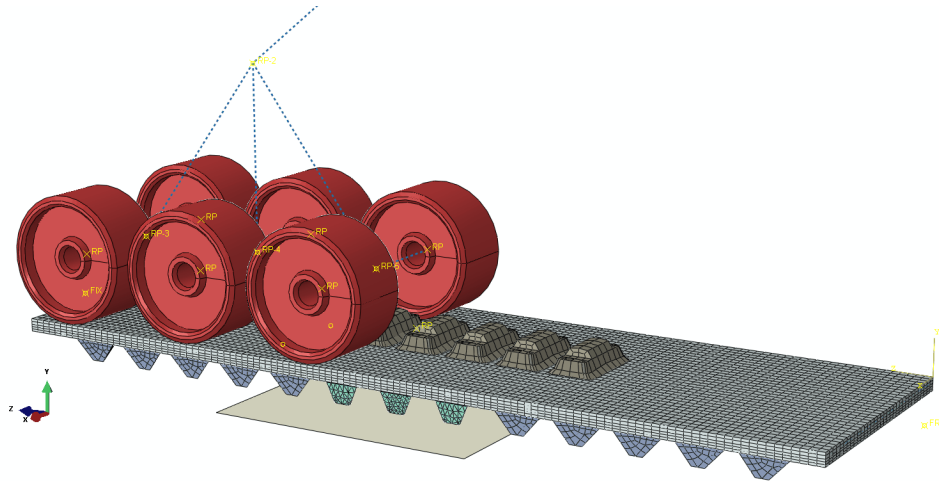
The methodology typically used for testing carcass solicitation is that of the “waterbug” test setup (as seen in Figure 7). In this type of setup instead of simulating the entire vehicle or the undercarriage track system, the model simulates only the behavior of a section of the track where the midrollers roll over. Since, it is believed the midrollers are the undercarriage components that carry the highest and most critical loads to the track.

**Figure 7 – Abaqus model for the Waterbug simulation test setup**

In order to ensure that this model depicts with authenticity the behavior of what happens in the field, certain procedures must take place. First, the section modeled needs to have the proper track tension that will see in the field. In order to do that, the track section is given a 0.1% elongation, which will represent the proper tension. That is, the track is fixed in one end to have  $U_x$ ,  $U_y$  and  $U_z$  equal to zero, meanwhile the other (free) end is given a  $U_z$  displacement of  $0.001 \cdot \text{Length}$ .

The length of the track section was taken arbitrarily. It must be long enough to accommodate the midroller assembly and the consequent rolling over. For this simulation, the length was equal to 2,232-mm.

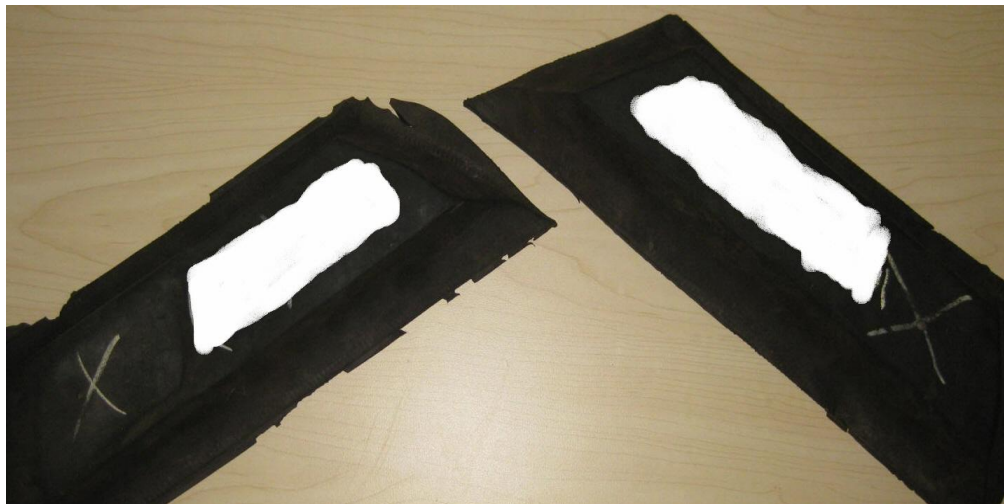
Two treads specimens were extracted out of a track in which the abnormal tread wear had occurred during the field test: One tread from the left side and another one from the right side of the tread design of the track. The following figure shows the top-view of the treads used for this visual inspection. The Optical microscope, by Lumenera Infinity 3 was used for this visual analysis process.

**Figure 8 - Left side and Right side treads, with the severe worn areas marked in white, and the less worn areas marked with an "X"**

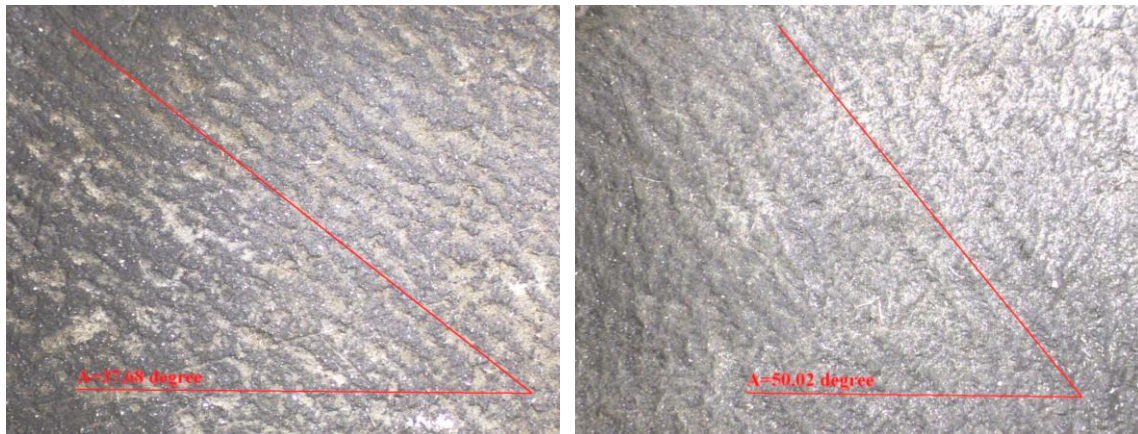
**Figure 9 - Typical wear pattern for a left side tread, at the center location (left) and outer location (right) at the less worn area of the tread**

The wear pattern at this surface was clearly very rough. There were found a lot of areas in this region depicting the abrasive type wear. But additionally, we could see indications of striation patterns in its surface. Optical measurements of the distance between the striations were in the order of 0.85-mm. to 0.92-mm. Another interest conclusion taken from this close-up visualization is the angle upon which these striations were formed, and how it varied in position within the contact patch. As it is shown in Figure 9, the striation orientations varied between approximately 50-degree to 30-degrees with respect to the longitudinal length of the tread, as it approached the more severed worn areas.

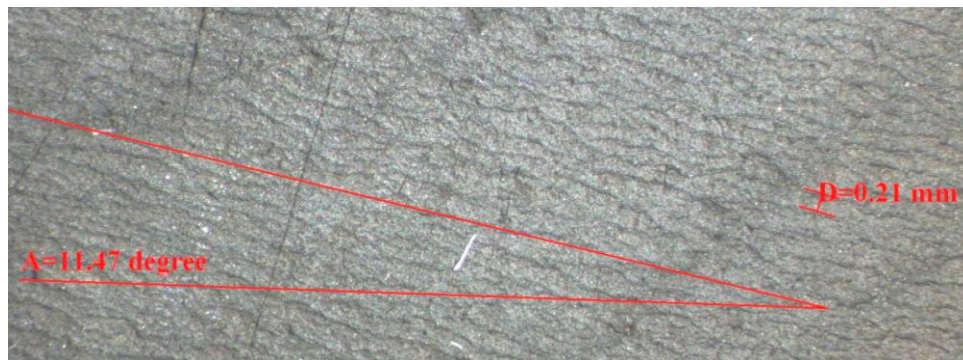
The following photo shows a detail image of the wear at the center of the abnormal wear area of the same tread (the area marked in white, in Figure 8). Optical measurements of the striations were between 0.12-mm to 0.20-mm. approximately. And the angle of these striations was clearly more parallel with the longitudinal length of the tread, with angles around 12-degrees. This worn area was very smooth, and these striations were hardly noticeable.

**Figure 10 - Closed up wear pattern of a typical, severe worn area**

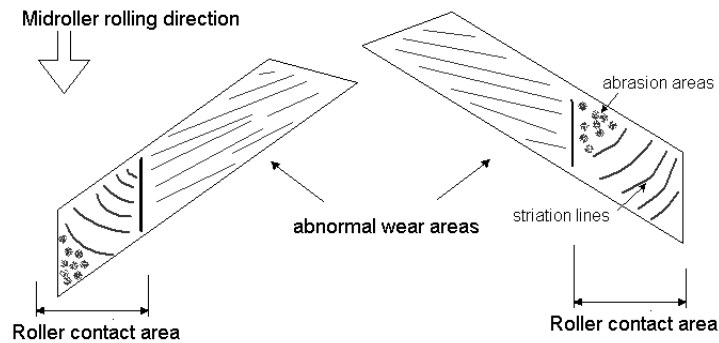
A similar wear pattern was found to be in the other tread, but since it belonged to the other side of the track, its wear characteristics was just a mirrored copy of the left-side tread. This tells us that the wear mechanism was indeed symmetric, with its plane of symmetry right at the center line of the track width.

The following image shows a schematic of how the wear pattern was found in these two treads. Note how the striation geometry is very similar in both treads, and how it is mapped symmetrically by the center of the track width.

**Figure 11 - wear pattern schematic found on the two inspected treads**

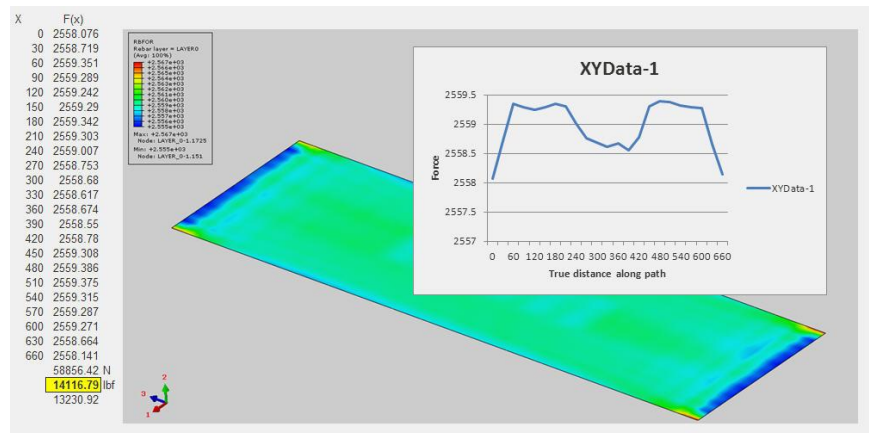
As it was explained earlier, the FEA model was fixed in such a way where one end is fixed and the other one is given a predetermined displacement, which creates the tension that is felt by the track when it is in placed in the undercarriage system. The following pictures shows how this tension was measured, using the 0-degree layer (which is assumed to carry most of the load) as our basis of measurement. The rebar forces were measured at the center of the layer, via a nodal path. This was done to avoid edge effects found at both ends of the track. As it can be seen a total from this picture, a total of 14,000-lbf was observed. In later analysis, the displacement condition was reduced in order to bring back the tension of the track to the more realistic value of 10,000-lbf.

**Figure 12 - RBFOR, rebar forces at 0-deg layer**

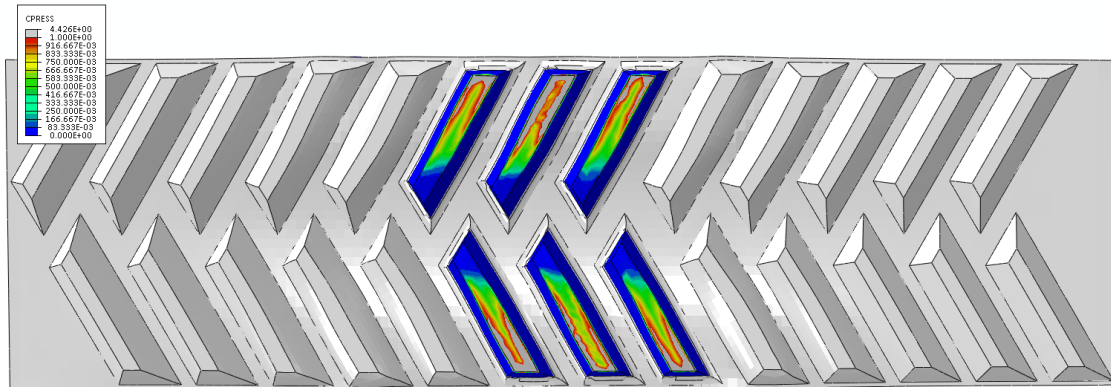
Output of the simulation was recorded in terms of contact results (CPRESS, CSHEAR, and CSLIP). The following picture shows the CPRESS distribution (contact pressure) plot when the middle roller is precisely lying in top of the middle tread bar. The CPRESS represents the magnitude of the normal force at the contact nodes.

**Figure 13 – CPRESS distribution; contact pressure**

As it can be seen from this image (for ease of display, the upper and lower limits were set to  $\pm 5\text{MPa}$ ), the pressure is mostly distributed along the tread bar area in which the midrollers pass by. This tells us that the tread bar pressure is not constantly distributed along its contact surface, but rather, that is proportional to the width of the rollers which induces the deformation of the tread bar.

The finite element analysis simulations provided us with a look at how the contact pressure was distributed as the midrollers passed by. The simulation model also gave us a mapping of the slip and shearing conditions at the ground to tread contact areas. We were able to see that the areas within the midroller influence suffered from very little slip and shear –friction forces, due to the high pressure values. On the other hand, there was large transverse slip nodal displacement at the area with poor contact pressure. These areas are therefore prone to the high cyclic fatigue wear found in the field studies.

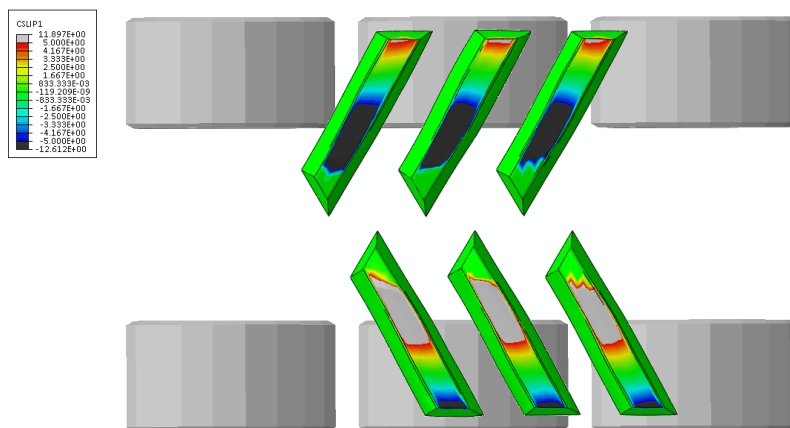
**Figure 14 – CSLIP1 distribution; transverse nodal displacement**

In this image, we can see how much a contact node displaces, normal to the direction of motion. The CSLIP1 shows the regions where most transverse displacement occurs (in the areas of black and grey colors), which in this case happens to be away from the CPRESS areas, the roller width section.

This tells us that the reason for the localized wear of the tread bars, at this particular section, has to do with the transverse motion that the tread bar suffers as the rollers pass by, and not by the directional motion of the tread bar. As a consequence, we can deduct that the wearing of material is mostly induced by the transverse frictional shearing of the tread bars. The following figure shows the CSTATUS, and tells us what areas of the contact are in slipping conditions (in green color).

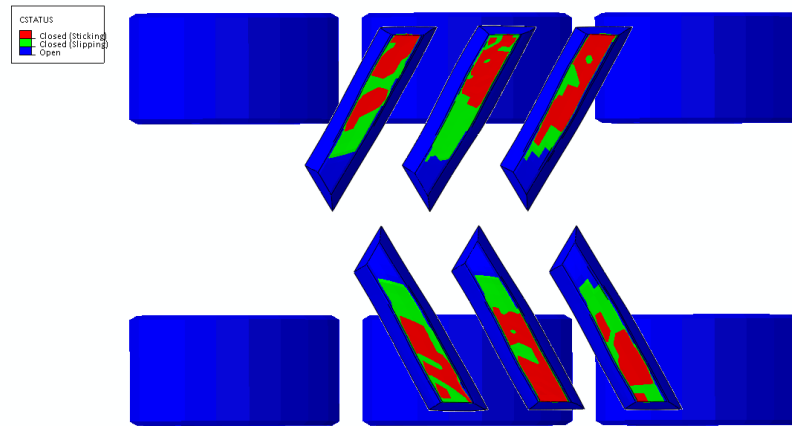
**Figure 15 – CSTATUS, contact characteristics at the tread bars**
