# USC Rocket Propulsion Laboratory: Experiences Modeling a Composite Combustion Chamber

**Abstract:** The University of Southern California Rocket Propulsion Laboratory (USCRPL) is developing a single stage sounding rocket that is intended to deliver a small electronics payload past the Kármán line at 100 km altitude. A full scale static firing of the solid fuel booster was required in order to obtain the necessary launch permits from the Federal Aviation Administration and Bureau of Land Management. Though successfully demonstrated in sub-scale static and flight testing, this entirely carbon composite combustion chamber experienced catastrophic failure during consecutive static firings. As part of the anomaly investigation into this ground test failure, the Composite Modeler for Abaqus/CAE was used to identify the root cause. The comprehensive model of the ground test was used to show that the ground failures were the direct result of loads applied by the thrust stand retention methods and a buckling failure of the thrust stand itself in the case of the second live-firing. In other words, the failure was a consequence of the ground test configuration. The capability and fidelity

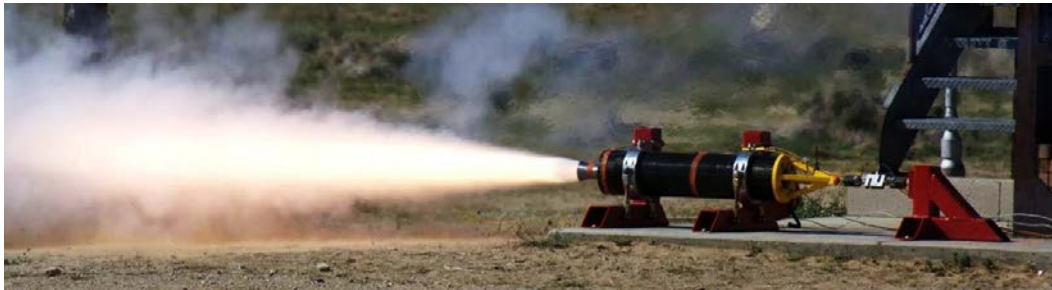
**Figure 2. Truncated motor firing.**

stand by means of aluminum clamshell rings, which clamped the outside of the motor case. These restraints resist vertical and sideways motion, but allow a small degree of translational freedom along the thrust axis. Thrust data was collected directly using an S-type load cell. Chamber pressure measurements were recorded from a tap in the head end aluminum bulkhead using a pressure transducer.

During the first firing, the motor suffered a failure in the nozzle structure. This created a larger than nominal throat area and subsequent decrease in chamber pressure. An increase in burn time was also observed. However, the second live-fire test (Figure 2) of this motor took place in April, 2010 and was a complete success. The motor performed to nominal design predictions, reaching a pressure of around 800 psi and had a burn duration of approximately 10 seconds, proving the feasibility of the carbon motor-casing at this scale.

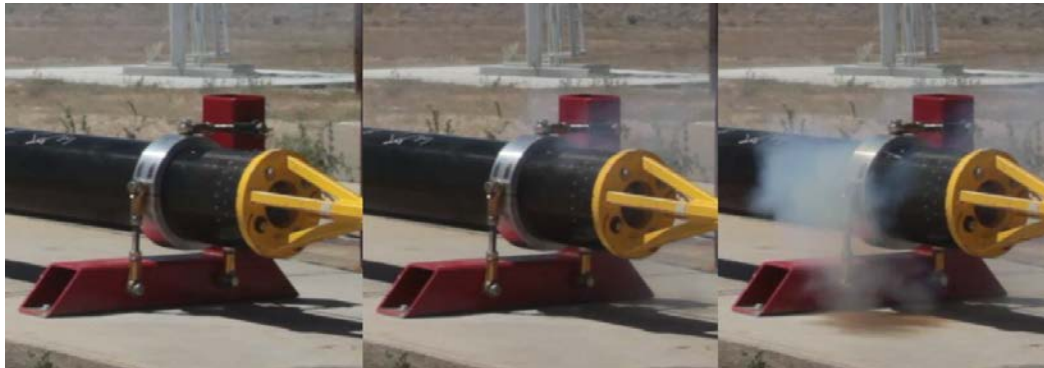
**Figure 3. Frame-by-frame lead-up to motor separation.**

Examination of video recordings of the test indicated that failure was initiated immediately adjacent to the clamp rings retaining the motor in the stand. Figure 3 shows stills taken from this video, roughly 0.02 seconds apart. The first frame shows the motor in a steady state condition, immediately prior to the anomaly. The second frame shows the first traces of visible combustion gases escaping from the motor. The third and final frame shows not only a greater volume of escaping combustion gases, but also shows what appears to be a ruptured parcel of filaments

deflected away from motor surface. The fiber rupture occurred along the forward edge of the retention clamp. A full rupture of the case immediately followed this image. The ensuing frame (not shown) is completely saturated with combustion products and no portions of the motor case or test stand remain visible.

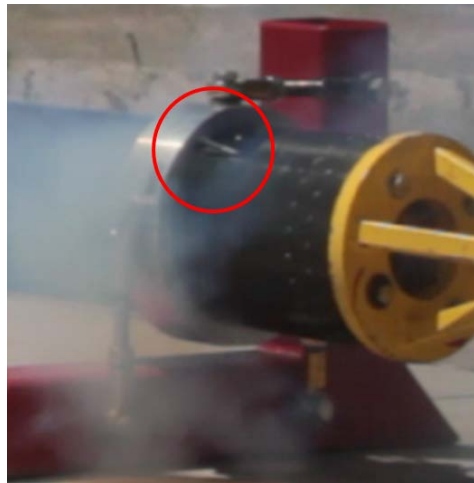
**Figure 4. Fiber separation visible prior to catastrophic failure.**

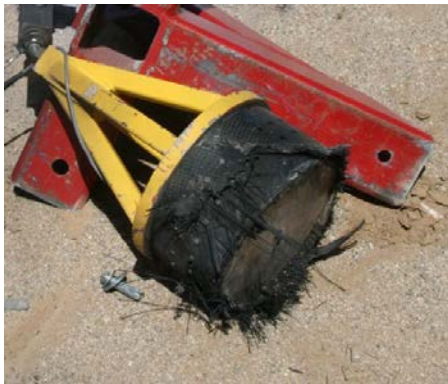
**Figure 5. Flight motor static test: separated forward end of motor casing, fragment collected near test stand.**

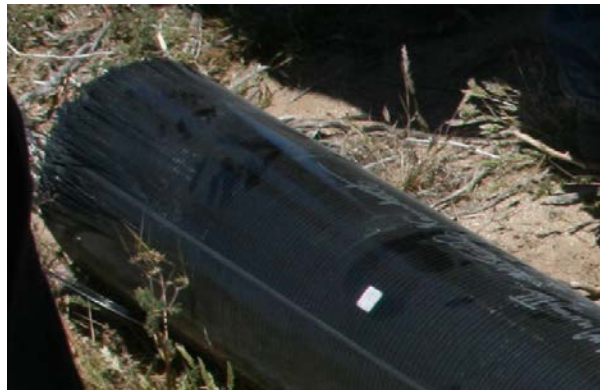
**Figure 6. Flight motor static test: separated aft end of motor-case, fragment collected approximately 150 feet from test stand.**

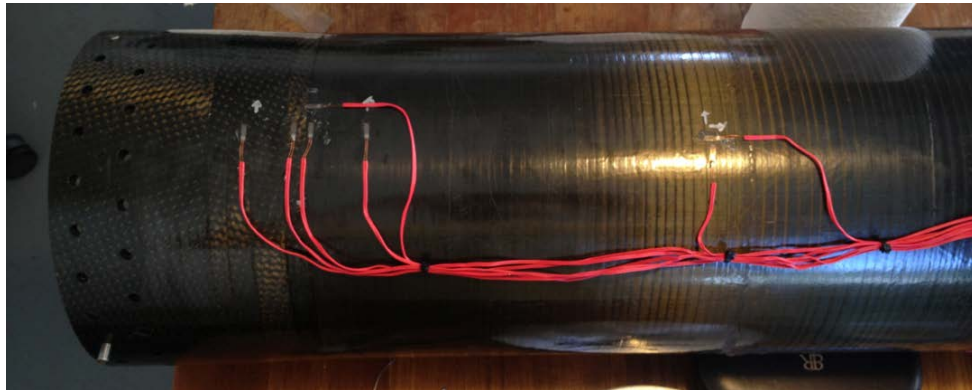
Through several iterations on model specifications, it became clear that the results of the finite element analysis are highly sensitive to material properties. That is to say, not just the scale of the results, but also the shape of stress profiles and where the model indicates problematic areas can change greatly with what appears to be a minor alteration in the material inputs. This means that input parameters must reflect the as-built material properties. Ideally, finite element results must be validated against actual testing. The original 1/3 length motor case was used for comparative testing, as shown in Figure 23. The case has been instrumented in order to collect strain data.

This case was hydrostatically tested up to the mean operational pressure of 800 psi while collecting strain data at several key locations in both the hoop and axial directions. Particular attention was paid to collecting hoop stress data at several overwrap thicknesses as well over the un-reinforced composite part both near and far from the reinforcement termination point.

**Figure 23. Recorded strain gauge voltage over time at several locations (b) for hydrostatic testing at several locations (a). Steps for holds are visible in the time trace, and overall voltage differential is clearly visible. Strain values are recorded as time averaged data points at 0, 800 psi holds.**

The results of this test indicate that radial expansion over the reinforced sections was much greater than predicted by the finite element model. Radial expansion of the un-reinforced sections was much closer to expected values, and in some cases over-predicted strain in these locations. Sample strain values are given below in Table 1 for several data channels in the hoop direction during one

test. Channels 1 and 2 are over reinforced sections, and Channels 3 and 4 are over unreinforced sections. What this data indicates is that either the anticipated stiffness of bi-directional reinforcements is significantly greater than reality, or the modeled ply thickness is larger than the as-laid up ply thickness of the reinforcement. The modeled ply thickness has been confirmed by measurements of the physical part, but as with the unidirectional fiber, no material property data has been collected for the bi-directional lamina. Because of this finding it is reasonable to question the validity of the shear stress concentration caused by the overwrap termination in the finite element model - at least until material property data has been collected for both fiber sets.
