# Predicting post-drop failure of ceramic chip capacitors using Abaqus/Explicit

Robert Bosch Engineering and Business Solutions Private Limited, Bangalore, India

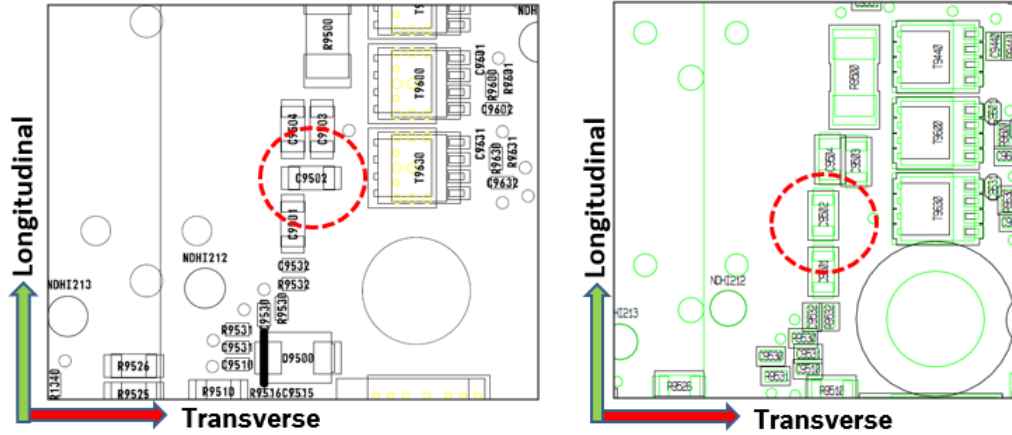
Fig 11. New layout decided based on the simulation results (old layout is included for reference)

An examination of the longitudinal sections reveal that there is almost no motion of PCB at the mounting location of the neighbouring capacitors as highlighted in figure 10. This explains why the other two capacitors did not undergo any damage during drop. The result also indicates that the capacitor can be re-oriented along the longitudinal direction to prevent damage. A careful observation again shows a possible hinge location very near to the capacitor location of interest. This was however neglected in the first instance and a decision on re-orienting the component was made. The altered layout is shown in figure 11.

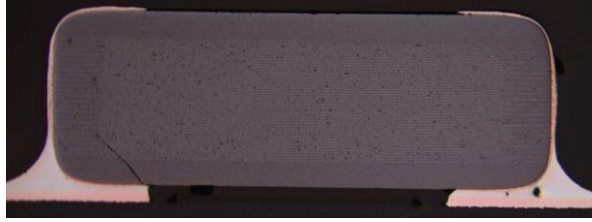
The DUT with revised layout was dropped under similar specifications. The device passed the post-impact functional test. In order to confirm the absence of damage in the c-chip, cross-sectional analysis was done. The cross-section showed partial crack on the component. The flex crack is shown in figure 12. Similar findings in quasi-static bending tests have been reported earlier.

Fig 12. Partial flex crack revealed through cross-sectioning

It may be unfair to undermine the predictive capability of the tool considering that the flexibility in extracting multi-step results and capability of visualization was indeed helpful in understanding the behavior of PCB. The effect of assumptions on the material properties employed, neglected hinge on the proposed location and the adopted strain limit itself add to the uncertainties in predictability of the model. Contribution of component removal method for cross-sectioning itself should be thought about [4]. A study using sub-models should aid us in appreciating the strains developed on the component. However as discussed earlier, a suitable material representation scheme has to be identified for such simulations for any benefit. In the presence of such uncertainties, the usage of Abaqus/Explicit for predicting drop generated c-chip failure using the discussed methodology is justifiable and quite beneficial for efficient product development.
