# Forensic Investigation of the Deepwater Horizon Blowout Preventer

Shane R. Finneran, Barbara N. Padgett, Brandon C. Rollins, and Neil G. Thompson

Det Norske Veritas (U.S.A.), Inc.

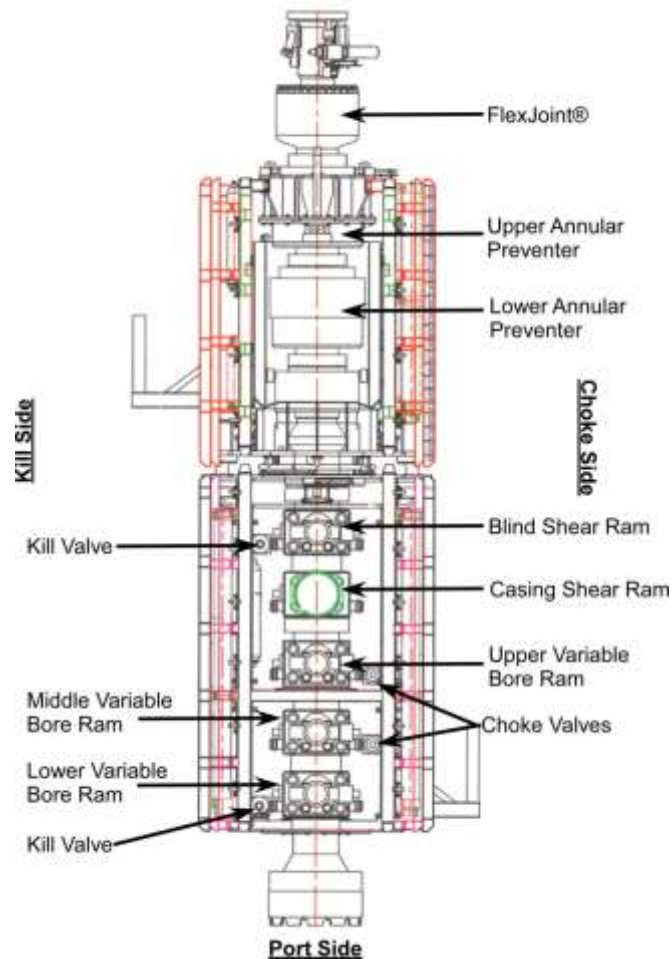
Figure 1. Schematic view of the BOP Stack as viewed from DWH port side

The LMRP (top) and BOP (bottom), shown in Figure 1, are approximately the height of a six-story building and weigh nearly 400 tons when stacked. In the event of a blowout, various components of the BOP Stack are functioned in an attempt to seal the well. The most important of these components are the BSRs, the large hydraulically actuated rams designed to cut the drill pipe and seal the well. The VBRs, UA, and LA can be used to seal the annular space in the wellbore, however, flow through the drill pipe will continue if these are activated. For the BSRs to contain the DWH blowout, they would have had to operate and completely sever the drill string, allowing the elastomer packers within the rams to contact and seal off the wellbore.

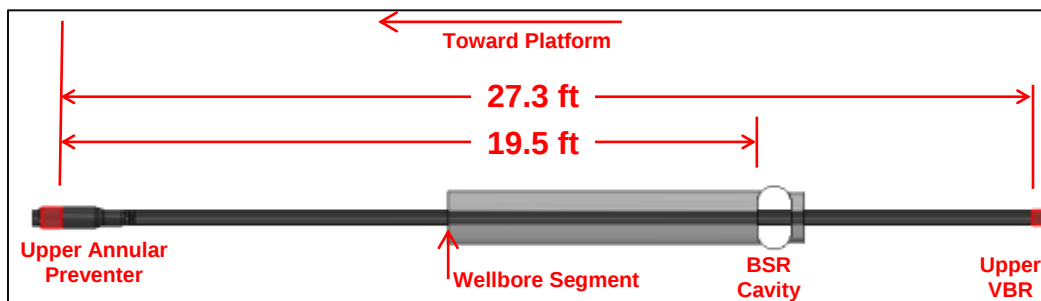
Figure 6. General layout of drill pipe and wellbore section. Note: Graphic orientation is rotated horizontal.

A three dimensional solid model was developed that included a drill pipe segment (including tool joint) that spanned from the UA down to the Upper VBR, the BSR cavity, and a section of the BOP wellbore, as shown in Figure 6. The drill pipe segment was modeled using the nominal geometry specified in API Specification 5D and API Specification 7 (API, 2009). The wellbore and the BSR cavity were modeled to simulate the displacement restrictions of the drill pipe within the wellbore.

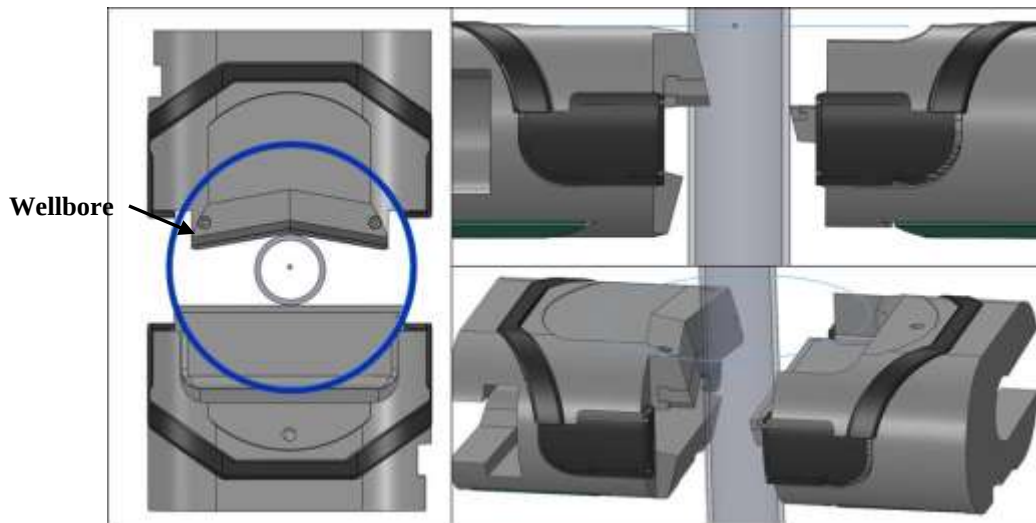
**Figure 9. BSR configuration**

Validation models were run to determine the forces necessary to cut the drill pipe when it is within the cutting blade surfaces (centered in the wellbore as illustrated in Figure 9). A 3Dshell model was developed representing the BSR blades, block faces, and a section of 5.5 inch diameter drill pipe as shown in Figure 10. The final geometry was modeled with 20,030 elements connected by 20,183 nodes. The blade surface models were developed from CAD models of the BSR provided by manufacturer. The drill pipe was modeled with shell elements and a specified thickness of 0.386 inch, per measurements of Pipe Segment 83. The ram faces were modeled with rigid shell elements as they were assumed stiff relative to the deformable drill pipe. Elastic and plastic material properties were applied to the model defining the behavior of the drill pipe as determined by mechanical testing.

A second model was developed to analyze the effects of the drill pipe being off center in the wellbore (displaced 0.5 inch from the inside wall of the wellbore as illustrated in in Figure 11). The upper BSR block had a single “V” blade design, intended to create a progressive shear, thereby reducing the necessary cutting force. As shown in Figure 9, the upper BSR blade does not extend fully across the wellbore.

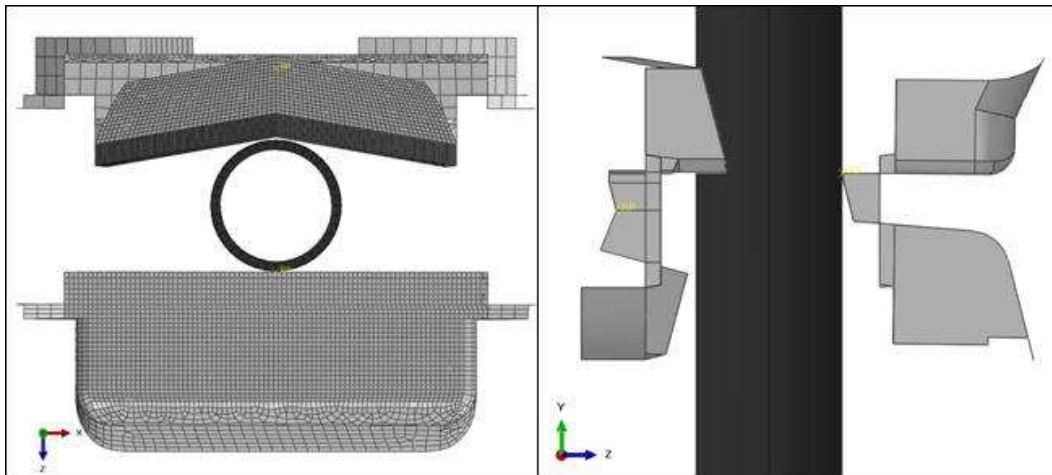
**Figure 10. FEA model of BSR blade surfaces and drill pipe**

The dynamic pipe shear models were solved using Abaqus/Explicit. The model with centered drill pipe calculated a maximum required shear force of 573,018 lbs. Design details provided the effective piston area for the BSR configuration as 238 in<sup>2</sup>. The model-derived shear force, when divided by this effective piston area, equated to a maximum ram pressure of 2,408 psi<sub>g</sub>. The FEA results were compared with shearing pressure results derived from multiple empirical methodologies proposed by multiple references, denoted as Method A, B, and C below (Kenney, 2010). Methods A and B below are based on a modified distortion energy theory equation, while Method A utilizes a proprietary empirical formula developed from extensive testing. The calculated results for the given conditions are given in Table 2. The FEA model results showed good agreement with the calculated shear pressures.

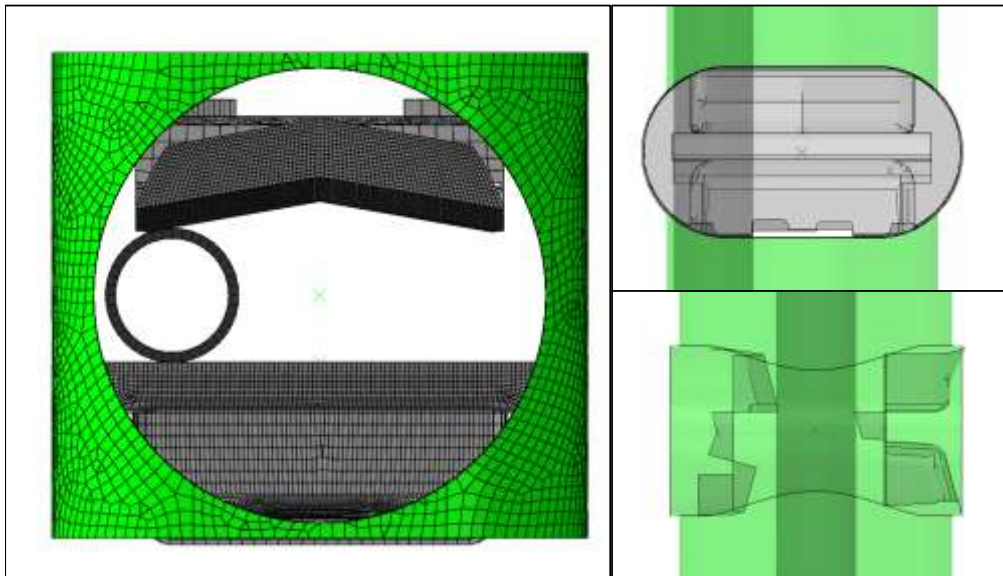
**Figure 11. FEA model of BSR blade surfaces and off-center drill pipe**

The off-center shearing analysis demonstrated that with the pipe at the edge of the wellbore, as observed on the recovered drill pipe and predicted by the elastic buckling FEA, the pipe would be deformed outside of the shearing blade. This would have prevented the BSRs from fully shearing and cutting the drill pipe, preventing full closure of the BSRs and sealing of the well. Rather than closing with the sealing surfaces in contact, the drill pipe was deformed and collapsed between the outer faces of the BSRs, outside of the cutting plane, as shown in Figure 13 and Figure 14. The final predicted FEA model simulation was compared with the recovered drill pipe as shown in Figure 15. As shown in the figure, the model of the drill pipe matched well with the indications identified on the recovered forensic evidence.
